DEPARTMENT OF THE ARMY  
HEADQUARTERS, 84TH ENGINEER BATTALION (CONSTRUCTION)  
APO San Francisco 96238

SUBJECT: Operational Report - Lessons Learned, 84th Engineer  
Battalion (Construction), for the period ending 31  
January 1970, RCS CSFOR-65 (R2)

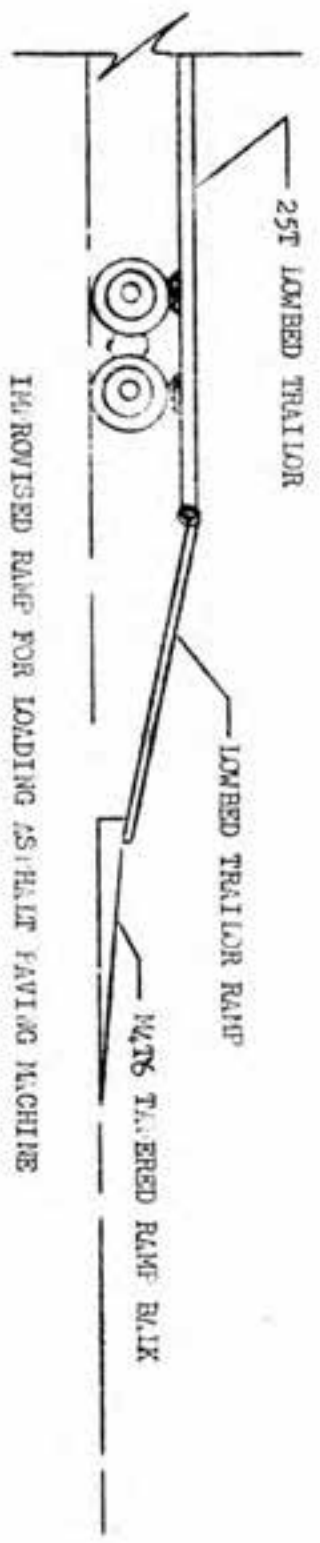
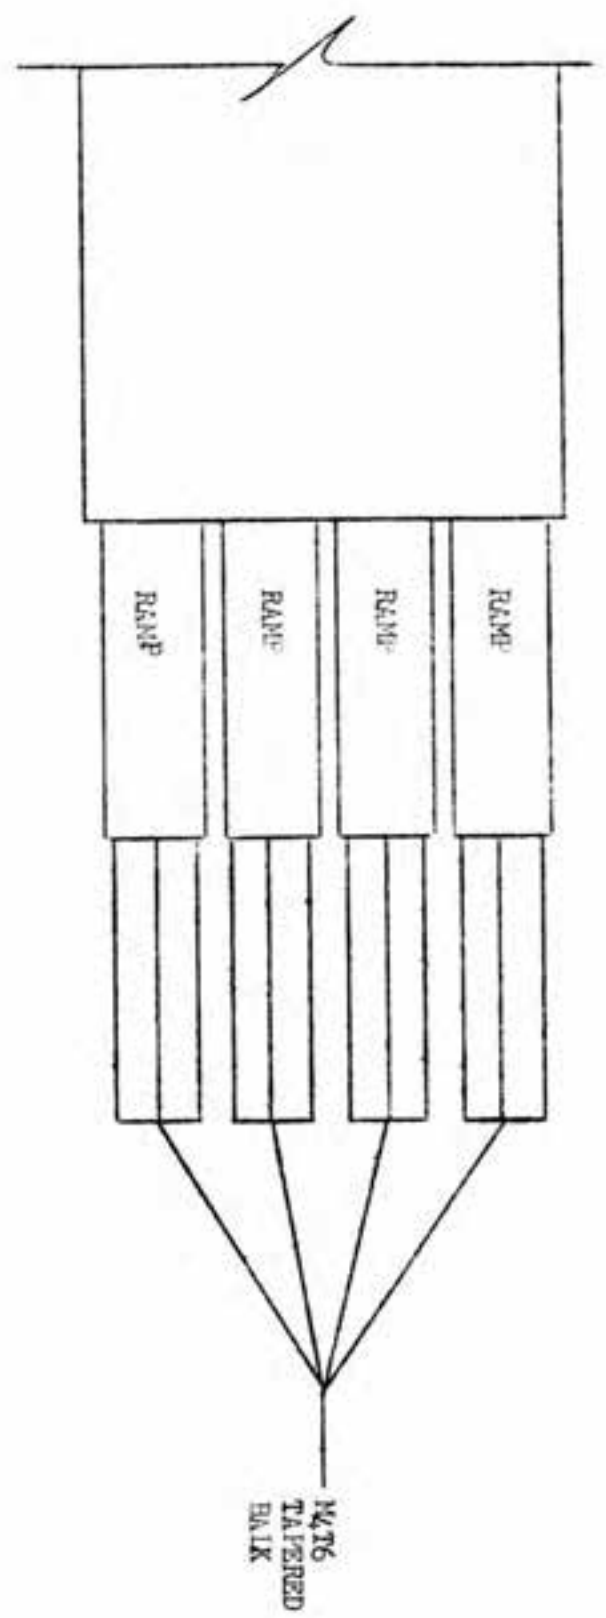
FIG. 1

IMPROVED RAMP FOR LOADING AS/HLT PAVING MACHINE

RECOMMENDATION: Two ramps were added to make a total of four ramps. Two M4T6 tapered bulk were placed under the end of each ramp to reduce its slope (see figure #1). The paver was then easily driven onto the low boy.

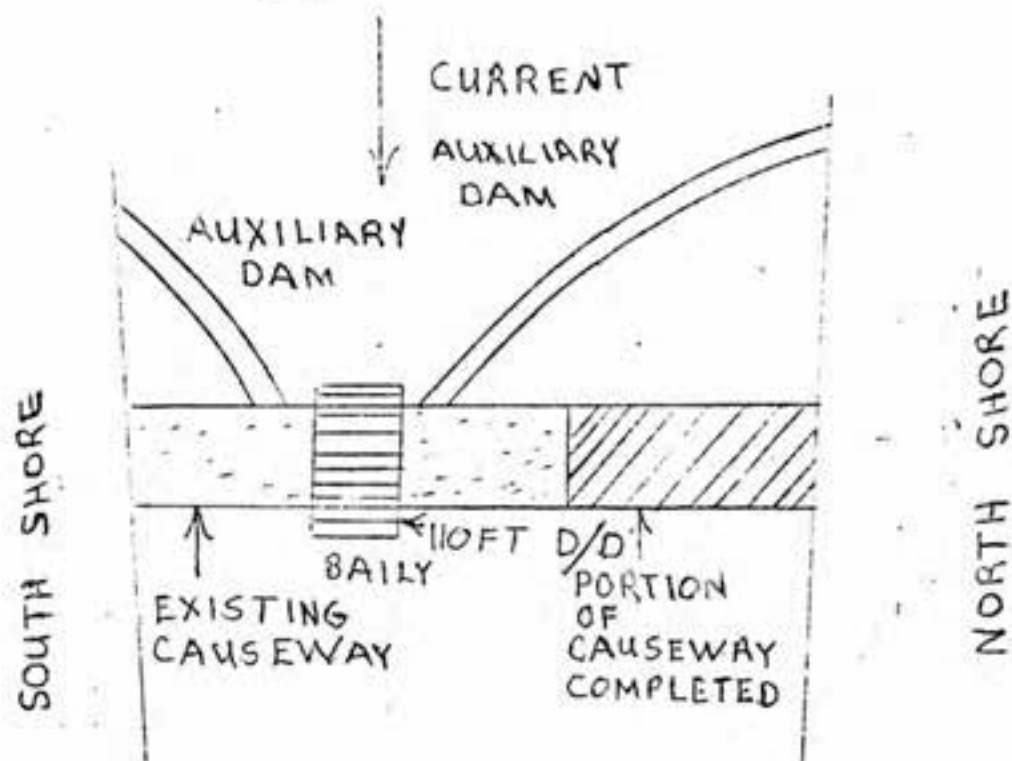
# CAUSEWAY

OBSERVATION: A causeway had been constructed 2/3 of the way across the Song Lei Giang River in Bong Son. This causeway was built to provide a working surface for construction tasks on the Bong Son Bridge. When the pile driving was nearly complete on the existing causeway, it was necessary to construct the remaining 1/3 of the causeway.

EVALUATION: Before constructing the final 1/3 of the causeway, a section in the middle of the existing causeway was removed and a 110 ft double double bally was placed over the gap. This gap would take the full flow of the river when the causeway was completed. Earthmoving was begun for the final 1/3 of the causeway and it was observed that much of the fill put in the gap was washed away by the current. This increased as the causeway lengthened because the narrowing channel increased the speed of the flowing water.

RECOMMENDATION: Before this became a major problem auxiliary dams were constructed by dosing sand from the river bed. One dam extended from a point upstream from the causeway on the north river bank to a point on the causeway near to and north of the bally bridge. The other dam extended from a point upstream from the causeway on the south river bank to a point on the causeway south of and near to the bally bridge. This is shown in the following diagram. These dams channeled the water into the gap which had been cut in the construction causeway. The final portion of the causeway was then easily completed.

b. Reference: Para 2(b)10. Causeway. A simpler method would be to add blast rock as a rip-rap at ends of the causeway adjacent to stream.
